### 3. Chicory Crop to Hilltop – B4221

Ditches and Grips – Proposal for Improvement

## 4. Crow Hill to SHGC – See Appendix 2

## Upton Bishop Parish Council (UBPC)

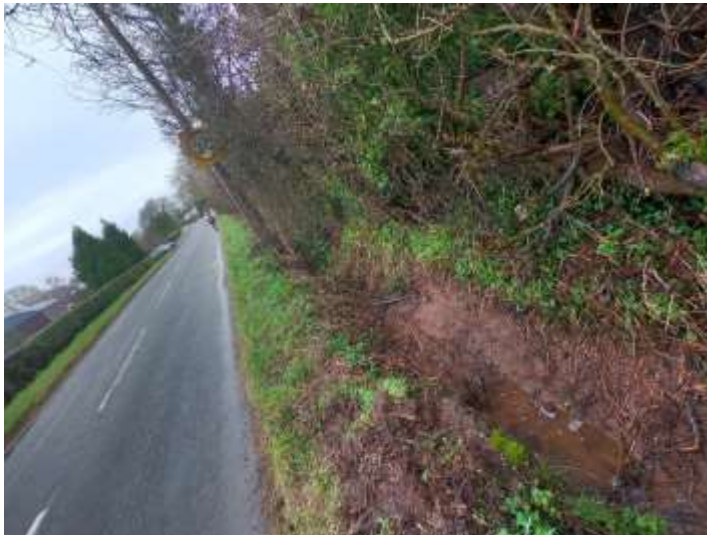
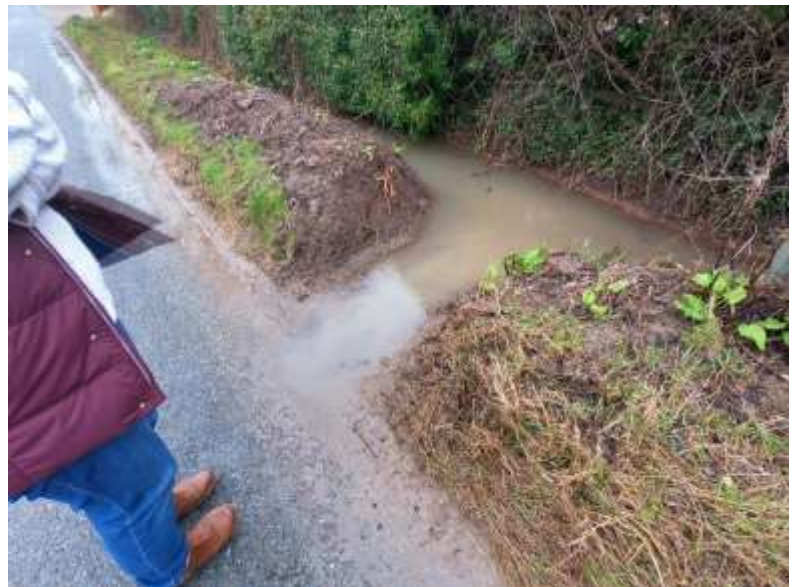
- 3.1. A forty-metre section between the Hall gate and the 30 mph sign needs the ditch lowering by about 600mm. (DE001 to GR003 Appendix 1)

Water is currently coming through the culvert under the Chicory Crop entrance but is flooding out onto the road because of the blockage in the ditch. This is a perfect example of how digging grips is showing up the shortcomings in the ditch profile.

The second photograph shows this; the end of the ditch that can be seen is the culvert coming under the Chicory Crop access and because the ditch needs lowering the blockage is forcing water out onto the road.

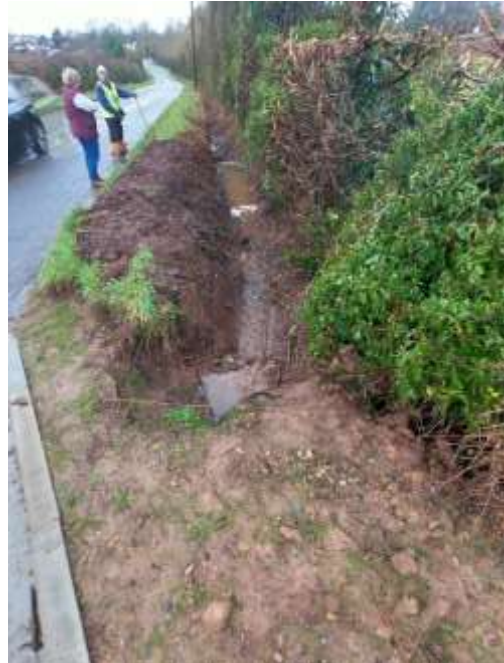
3.2. Welsh Water Entrance (GR006 App 1)

Water is flowing out of the new culvert and into the ditch. This ditch has not had water flowing in it for years and the flow now continues on down to the culvert crossing at the Hall. However, some water is still running down the roadside and it would benefit from an additional grip dug at the edge of the access road to prevent this.

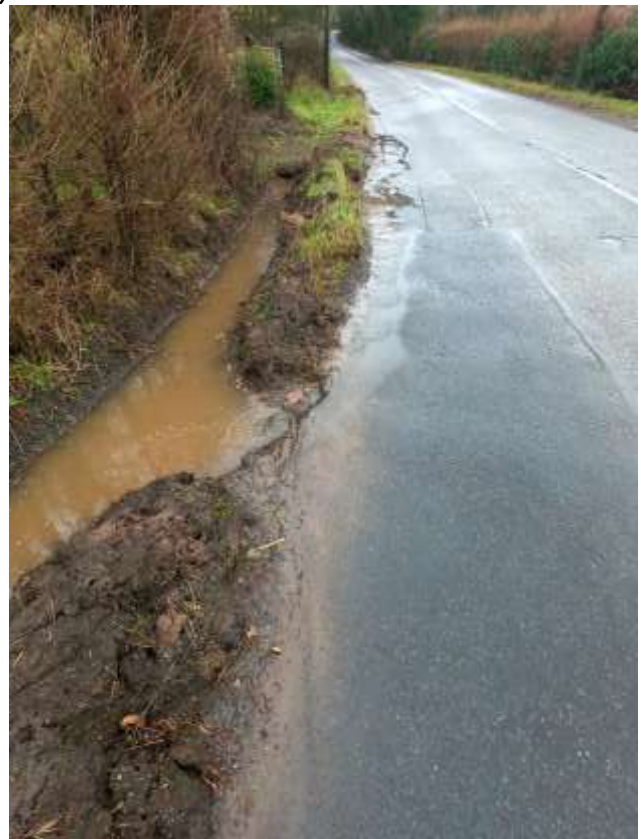
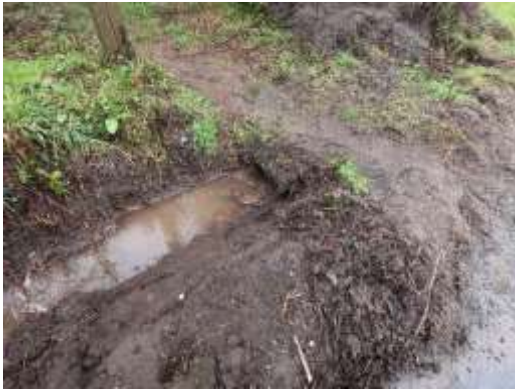
3.3. Felhampton (CU9 & 10 App 1)

The flooding across the road at Felhampton has been largely alleviated, but a small amount of work would resolve the issues completely. The flow of water coming out of the Welsh Water culvert represents the flow into the ditch at Felhampton as can be seen here. Unfortunately, it is being forced out onto the road by a single blocked culvert about 30 yards up. This can all be resolved by jetting the culvert.

There are two culverts at this location, one under the footpath which is the lower of the two which must be partially clear as water is flowing out of it.

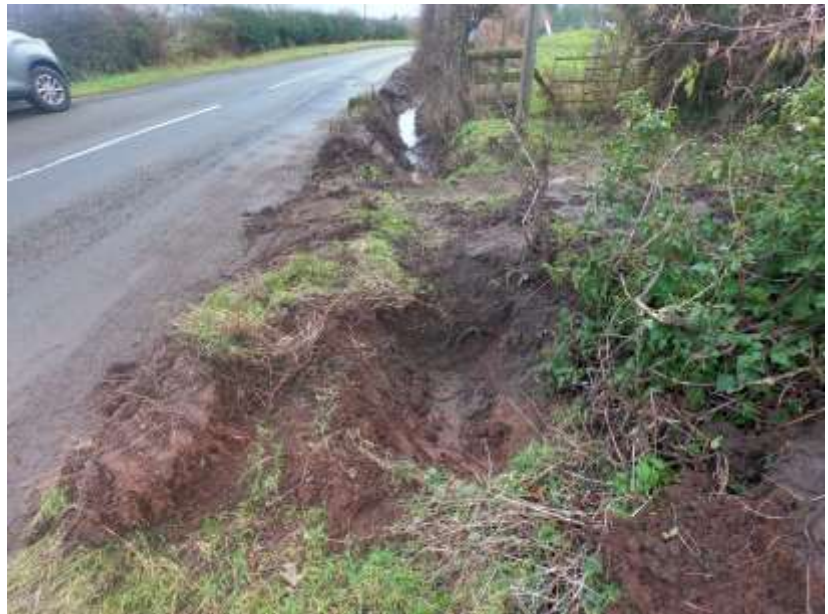
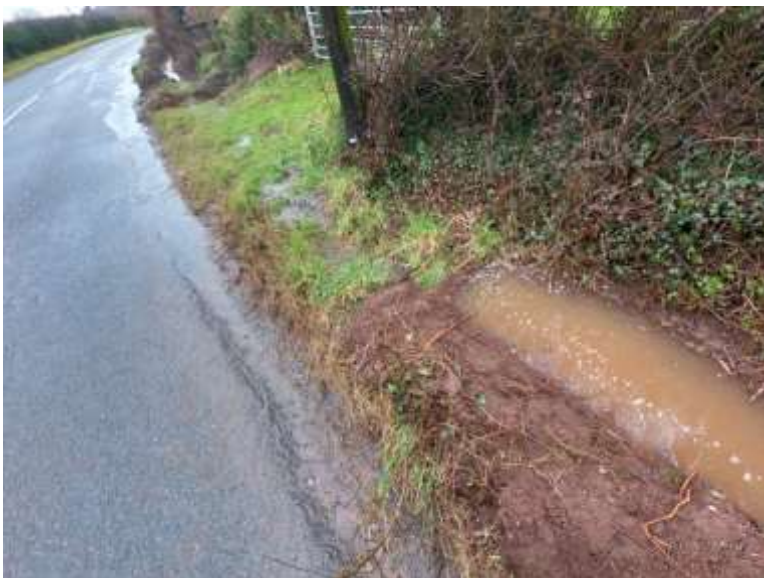
Looking in the opposite direction, i.e. down the hill, the picture on the right shows the culvert under the field access is blocked and it is this that is forcing the flow of water out onto the road. This culvert was exposed by BB during their grip excavation work but it is clearly blocked as the next picture shows.

The sad thing about this is that all of the water in the ditch is as a result of the new grips successfully cut further up the hill. This blockage is spoiling all of the good work done further up. Again, water is flowing down here for the first time in years and the only thing preventing the water staying off the road is this single blocked culvert. A short blast with a jetting nozzle would resolve this issue and stop water from re-entering the carriageway.

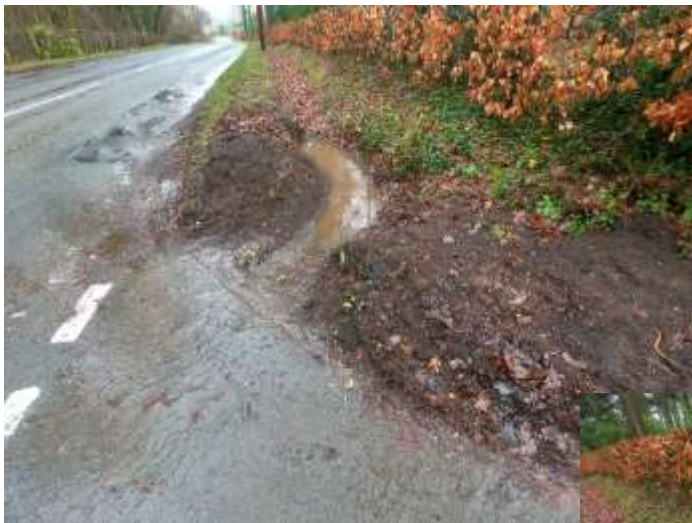
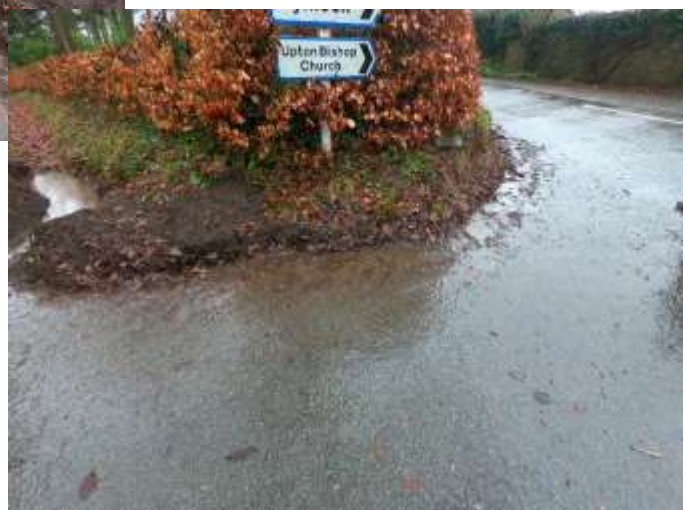
3.6. Hilltop (GR020)

There remain two issues at Hilltop. The first is a simple modification to the shape of the grip as agreed at the site meeting. Water is currently missing the grip/ditch and flowing out onto the B4221.

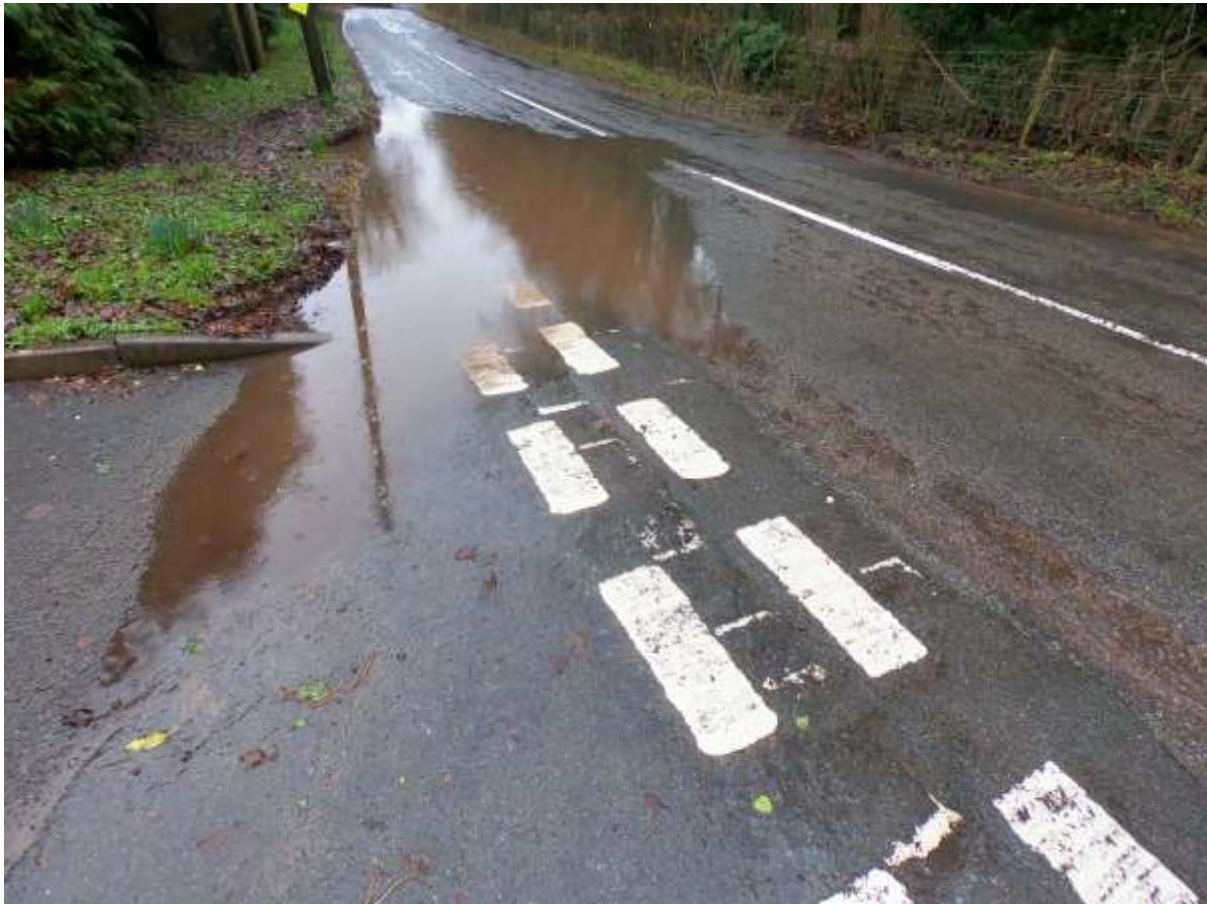
The second problem is the flooding that still exists whenever it rains and whilst this has been partly alleviated by digging a grip on the south side, there remains a significant road traffic hazard, especially as this is next to a bus stop.

It was hoped that BB would investigate the possible existence of a culvert beneath the C road, but this did not happen. Clearly this situation cannot be allowed to persist and the digging of a trial hole/slit trench about 1 metre deep adjacent to the kerb would prove either way if the culvert exists. If it does it will need cleaning and opening out into the ditch pictured above. If it does not, an alternative way of draining the road will need to be found. Either way a solution is needed.

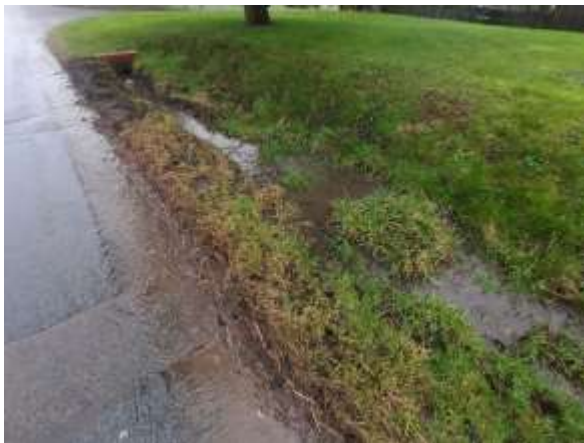
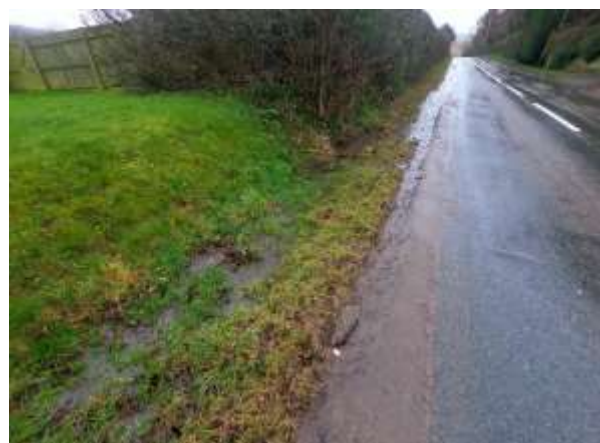
### 4.1. Spring Meadow to Lower Rylands (see Section 1 in Appendix 2)

During the site visit, the attention of BB was drawn to the problems at Spring Meadow. Water is running down the B4224 and needs channelling into the roadside ditch. Grips would help. Unfortunately, this ditch only runs for about 30 metres before ending and the water then pours back onto the road.

This is an example of where a roadside ditch is needed to clear the road. It is not a landowner issue. The damage that is being done to the carriage way is immense and the small cost of digging a roadside ditch would be insignificant compared to the costs of repairing the already damaged road surface. Edge erosion on this section is spectacular and up to 200 mm deep in places. A cyclist slipping into this trench could be seriously injured or killed.

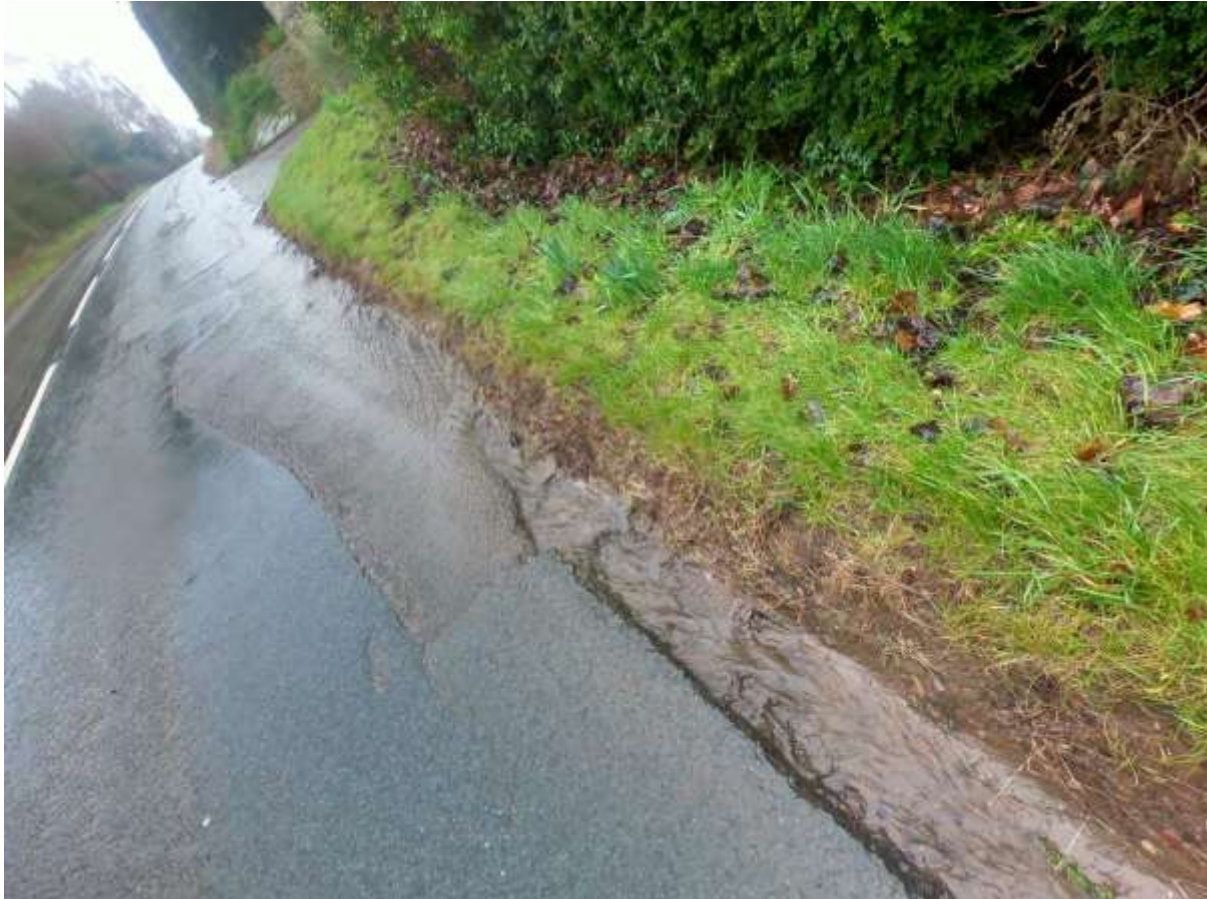
4.2. Lower Rylands to Road Culvert (Section 2 in Appendix 2)

It is unclear if a culvert exists under the access to Lower Ryland but this could be installed if not at low cost in comparison to the road damage that is being inflicted.

Just past Lower Ryland at the point where the road edge erosion starts there is clear evidence of a roadside ditch that is completely dry while the water ravages the road edge. This is not verge erosion, the carriageway is clearly damaged.

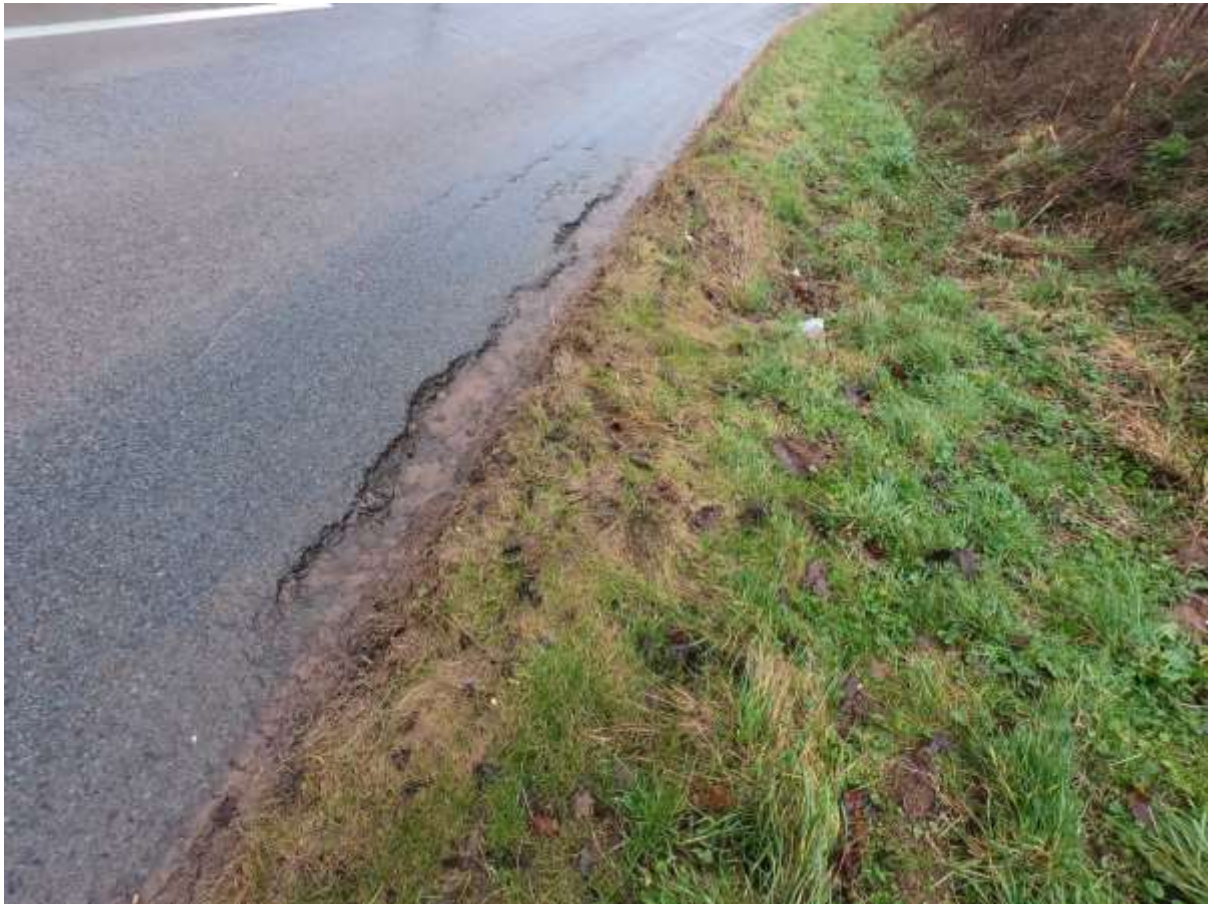
4.3. Culvert Crossing between Felhampton and Sandford Farms  
(See Section 3 Appendix 2)

Water from Felhampton is flowing freely into the roadside ditch and across the road in the culvert. This flows out onto the fields of Sandford Farm and away, as the riparian rules intend. Free flow of water across adjacent land parcels. At the crossing, the road regularly floods, and BB were asked to visit this spot to recommend options to alleviate this. It is not clear that this happened. It is clear when looking at the roadside ditch that there were grips at one time that have been allowed to fill in resulting in serious damage to the road edge. Again, water flows freely down the damaged road while the ditch remains dry. Grips need to be re-established to alleviate this flood area.

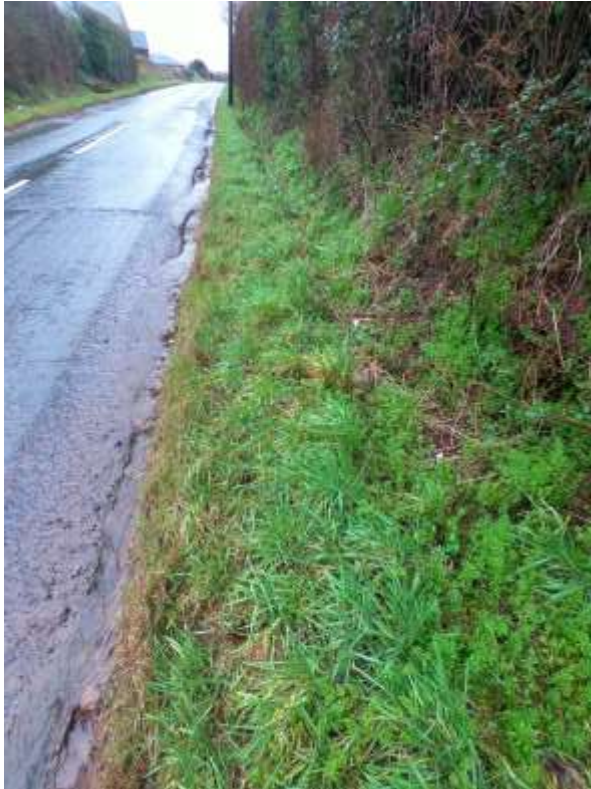
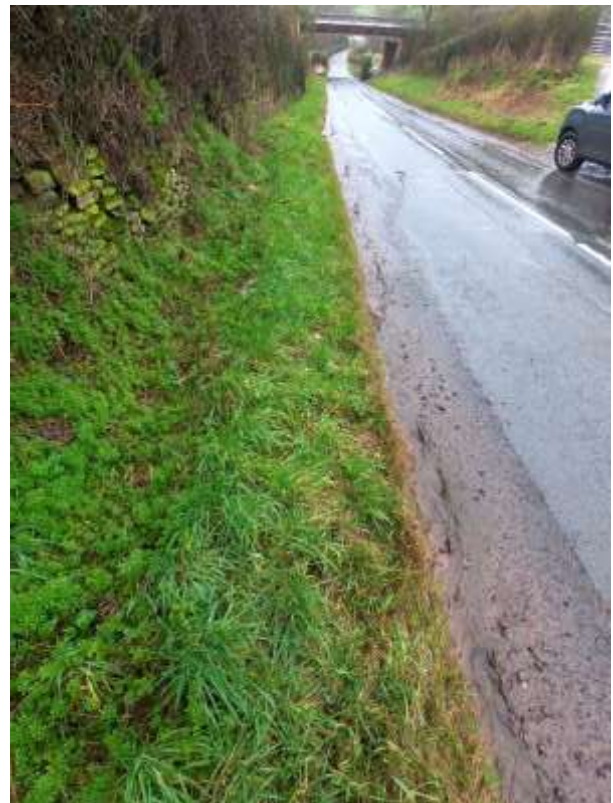
4.4. Sandford Farm to Rudhall Brook

Below the farm there is evidence of ditches on both sides of the road, both of which were dry while water flooded down the road causing further edge erosion.

Grips are needed cut at acute angles to force this water into the ditch and down towards the M50 crossing. It is unclear what happens when this ditch ends but forcing the water into the ditch will show if there is a culvert.

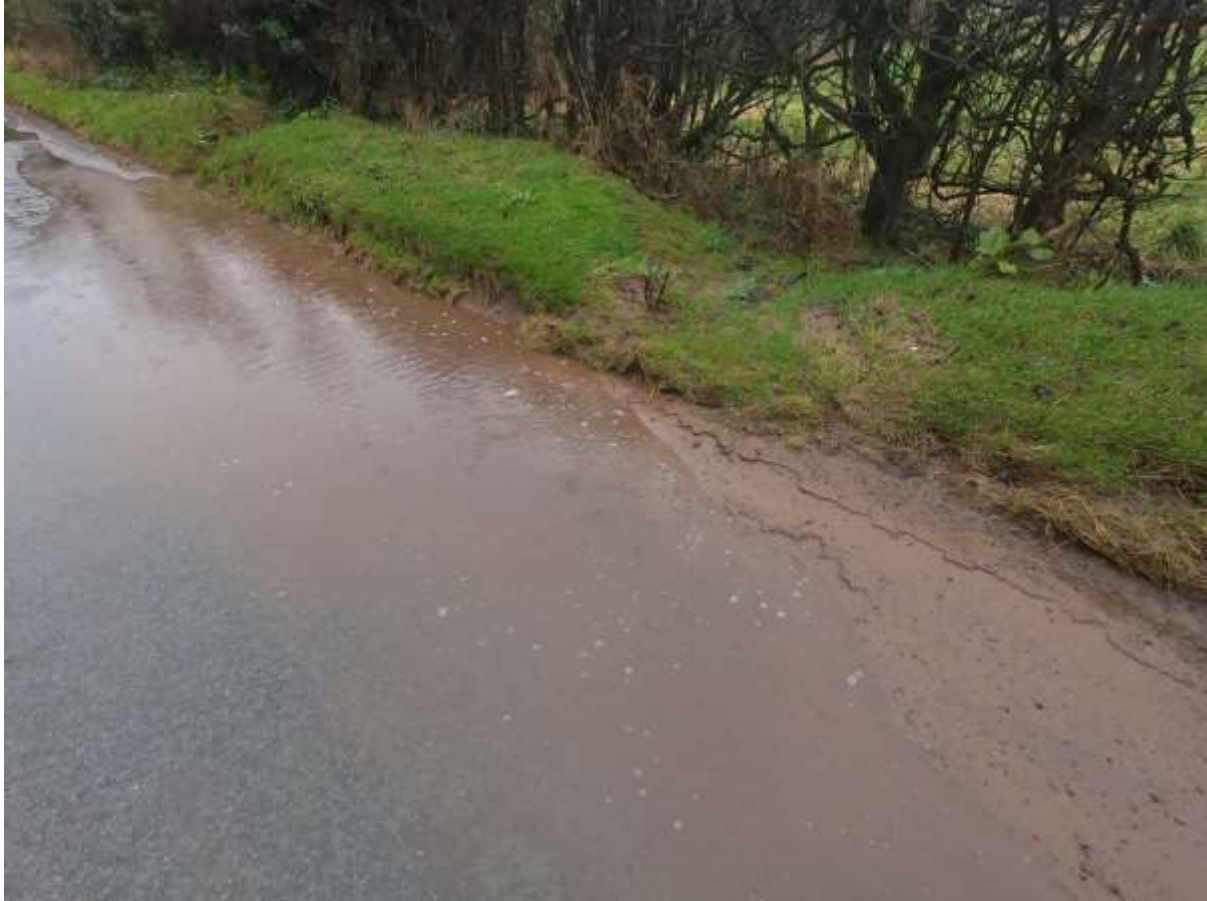
Below the M50, where the ditch recommences a culvert is running freely into the ditch and on down to Rudhall Brook although further ditch and grip clearance may be needed on this lower section.

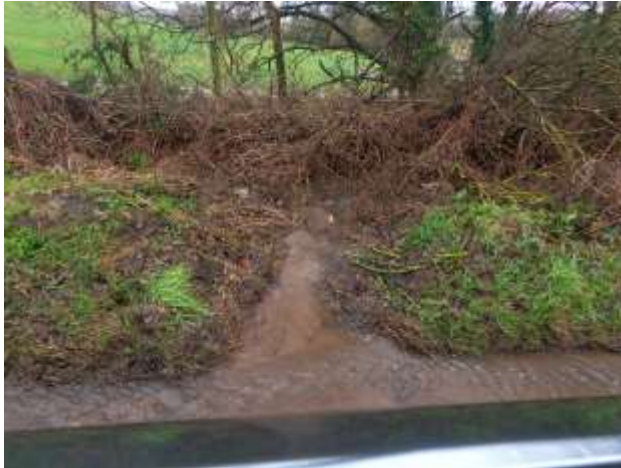
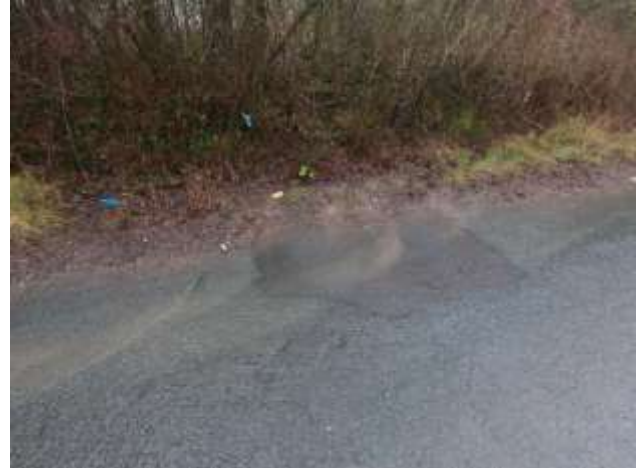
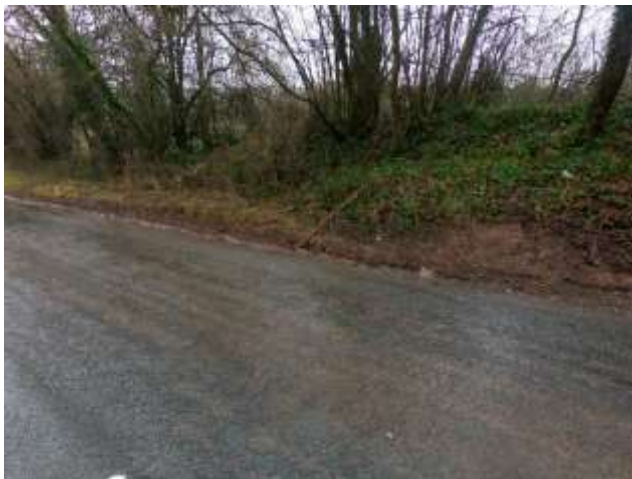
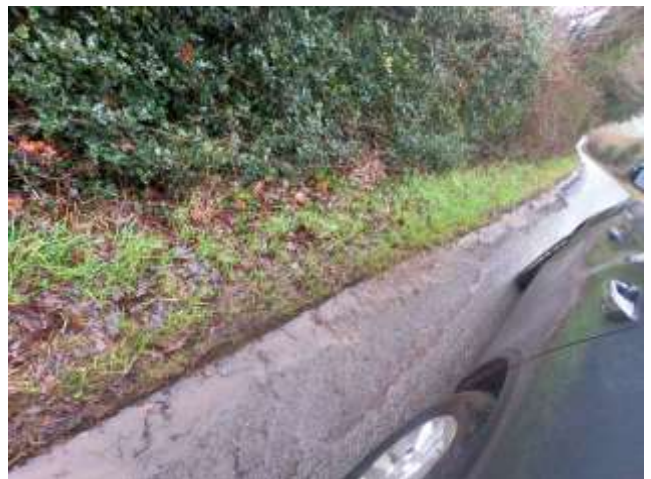
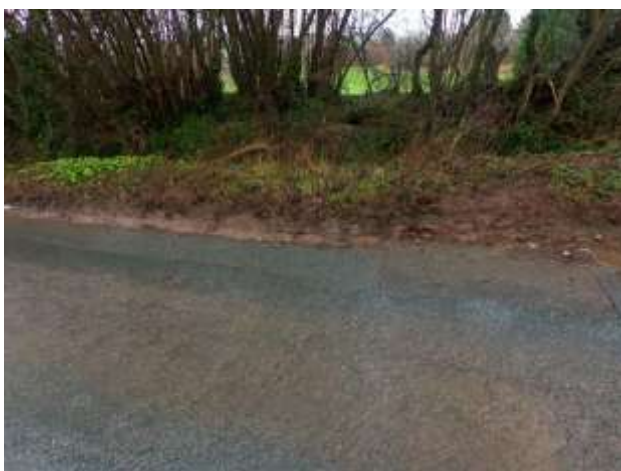
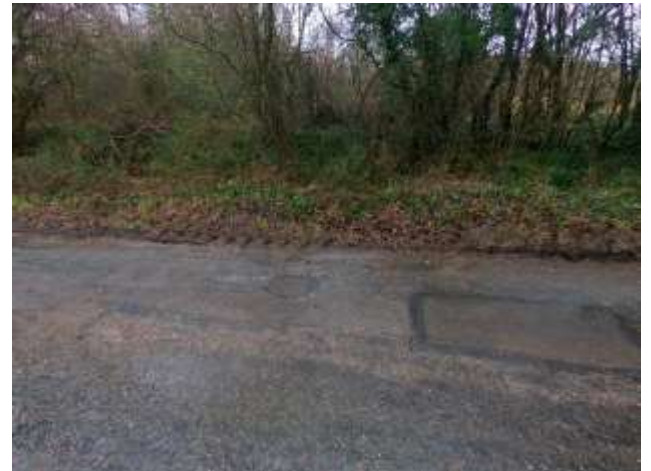
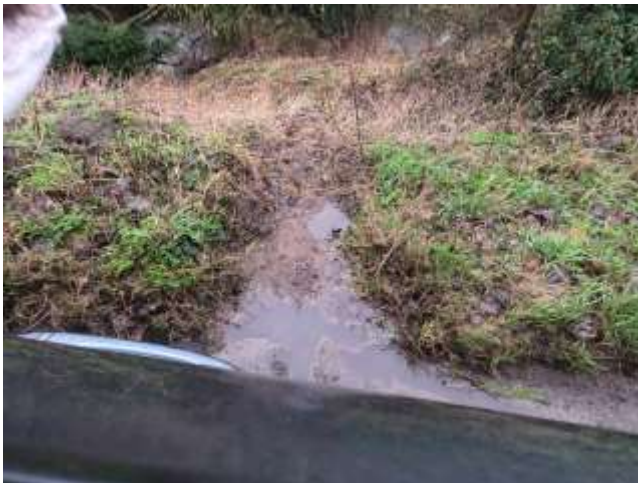
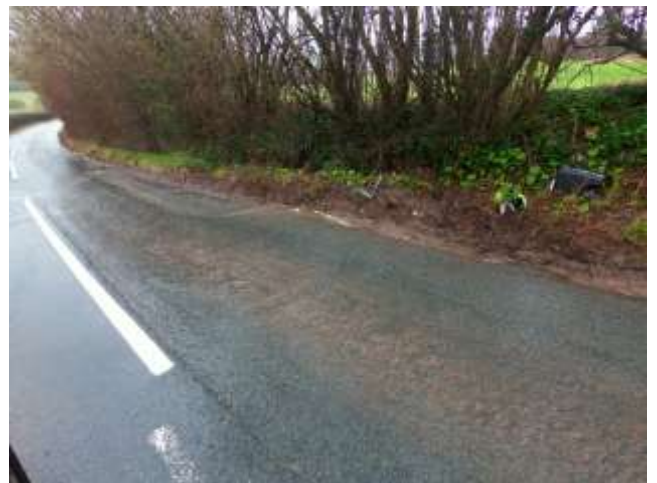
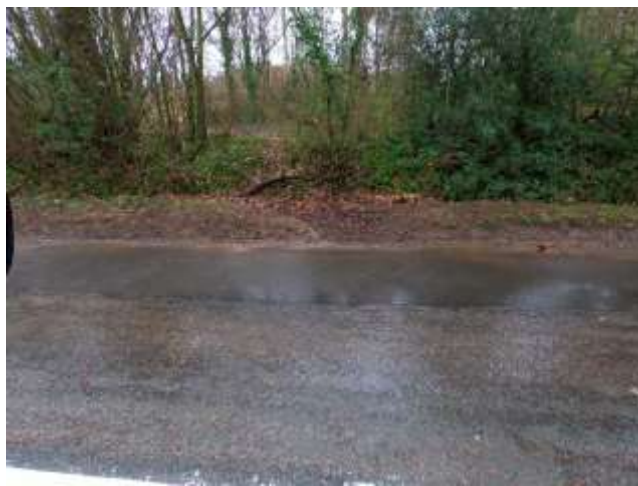
## 5. SHGC to Bromsash

Although this is Linton Parish, it is worth pointing out the massive amount of road damage being done on this section. Frustratingly, there is a perfectly good roadside ditch running the length of the golf club that is completely dry. There is even evidence of old grips that no longer function.

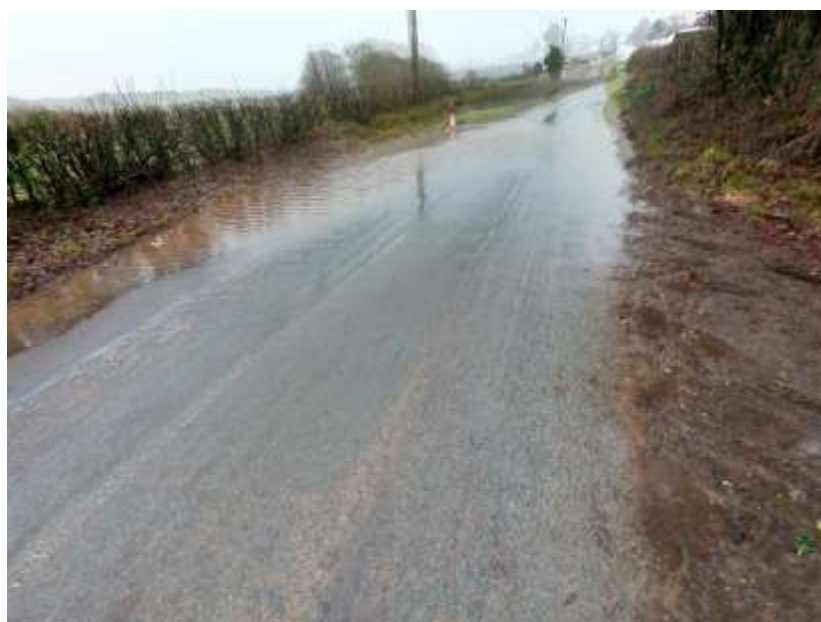
There is also serious flooding at the edge of Bromsash that has still not been resolved despite prior visits by BB.

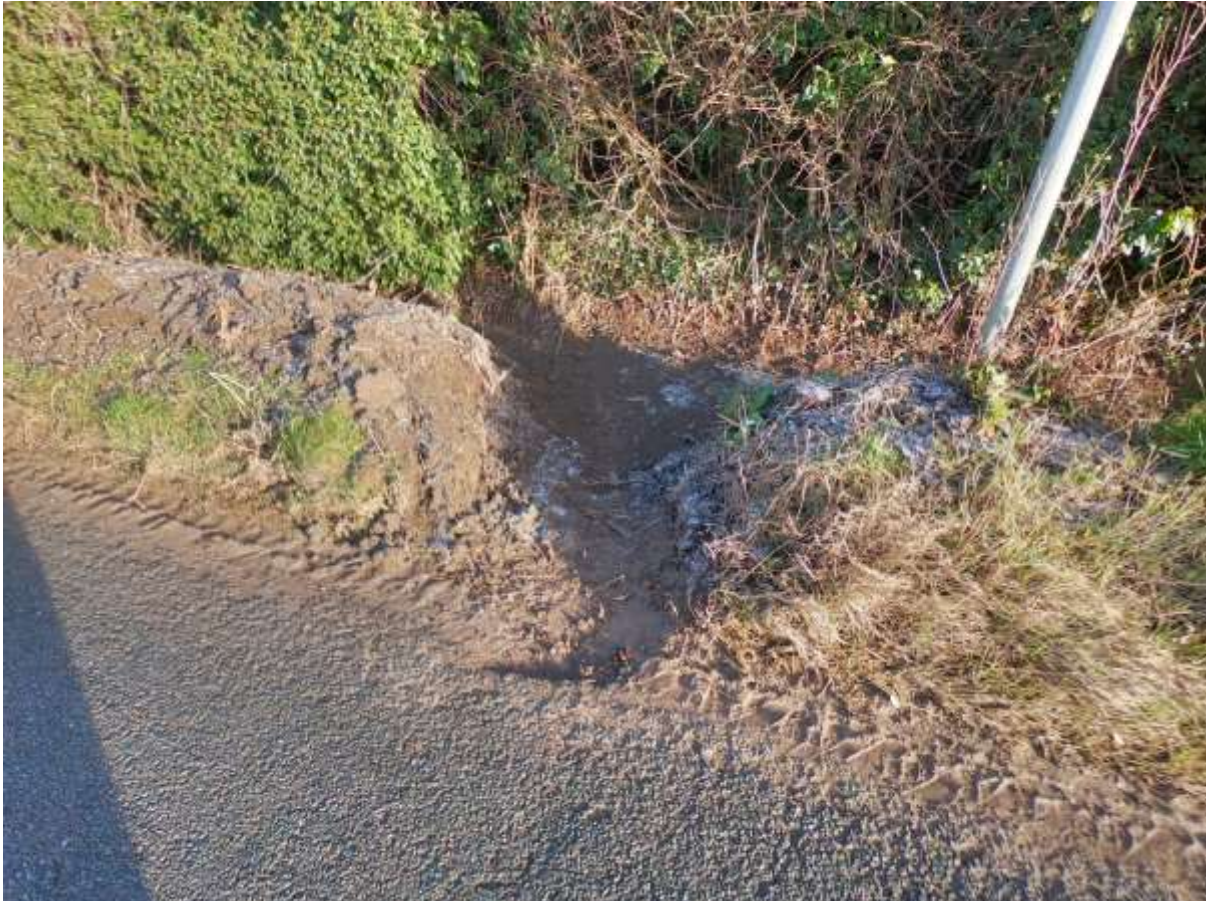
### 11.1. Grips cut at 90 degrees

Grips cut in this way have limited ability to capture water flowing past them. Water will tend to run straight past. The grip is narrow, there is little clear definition of the side walls and spoil piled at the sides will simply wash back in. The bottom of the grip is only just below road level and will quickly silt up again.

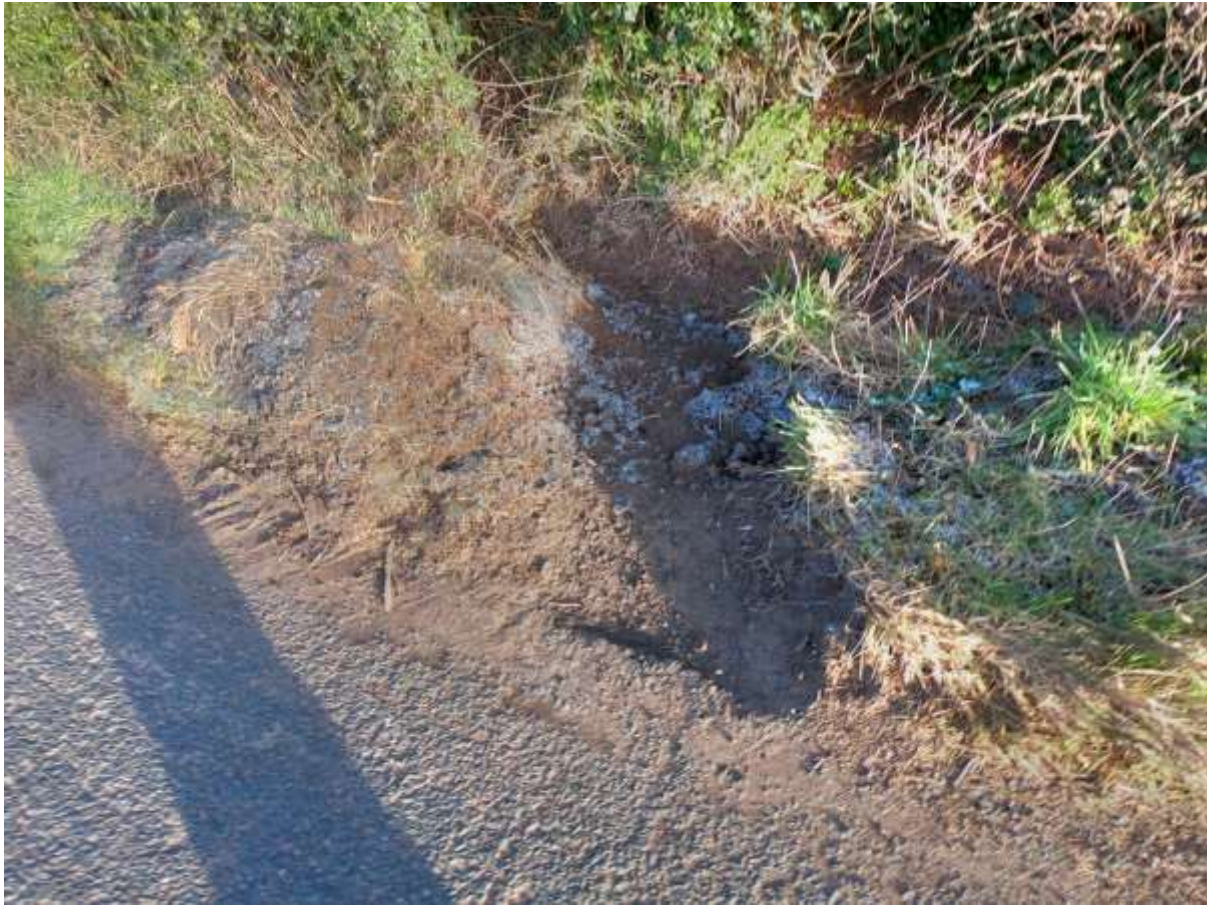
11.2. Grips Cut at 45 degrees

Grips cut at an angle are more likely to encourage water to flow from the road into the ditch. However, the uphill edge is still shaped to discourage this. The depth of the grip is better sitting well below the road surface.

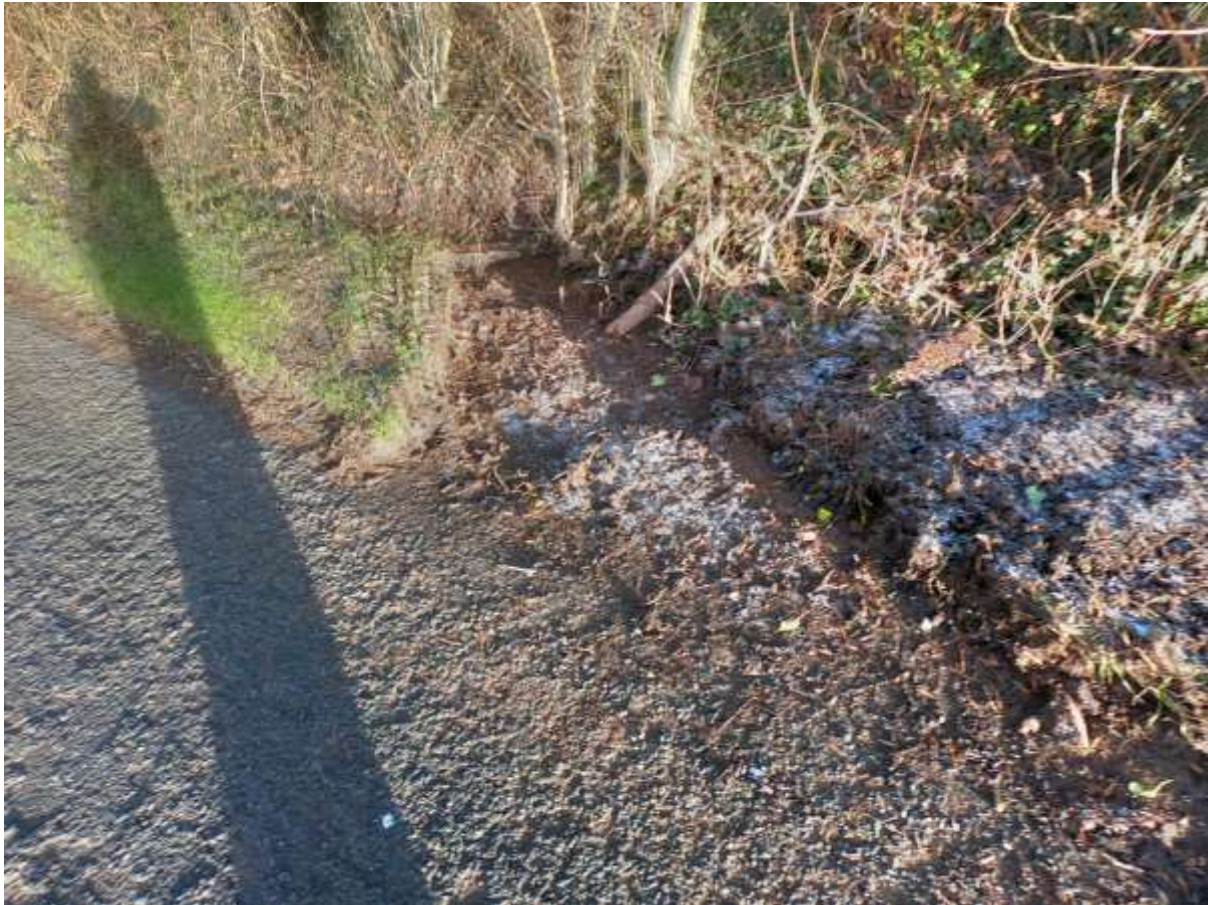
Grips dug at 45 Degrees with lead-in Edge

Of all the grips cut by BB on the B4221, this one stands out as being the best. Although it would benefit from a little more taken from the bottom, the sides are well defined, the lower face is at 45 degrees, and the upper face is cut back at a much more acute angle to encourage water to run off the road. The mouth at the roadside is much wider and the throat is at least 600 mm wide. This should be the standard for all grips.
