Parish of Upton Bishop

Baseline Survey Report on Parish Public Rights of Way

September 2019
Andy Parr

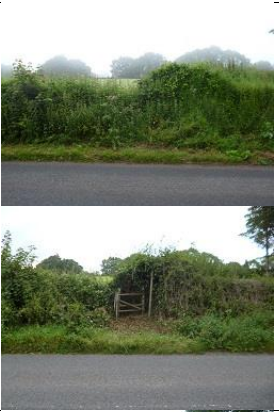
UB12 No	Moving SW to NE Distance; 106m	C.rd. 230 yds. WNW of Hilltop	C.rd. 200 yds. NW of Hill Top		
No	Feature	Condition	Action	Grid Ref	Photograph
UB12/1	Wooden stile & signpost	Poor Overgrown and not accessible. Stile rotten and needs replacement.	Clear vegetation New stile & sign post Vegetation cleared roadside	SO 64875 26639

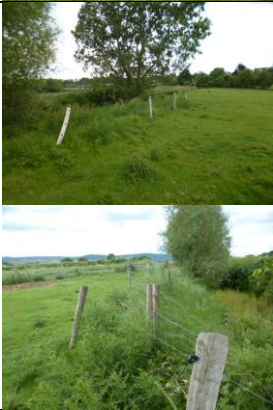
UB13/1 to UB13/2	Footpath separated from field by electric fence	Poor Pinch points created by electric fence	Clear vegetation Widen path at pinch points to avoid electric fence on one side and barbed on the other.	SO 64233 26497
